# Manhole Inspection Summary

Manhole # S23QQ1004MH

Insp Date: **12/4/06 10:50 AM**

**Location** Address: **222 HILLSIDE RD**

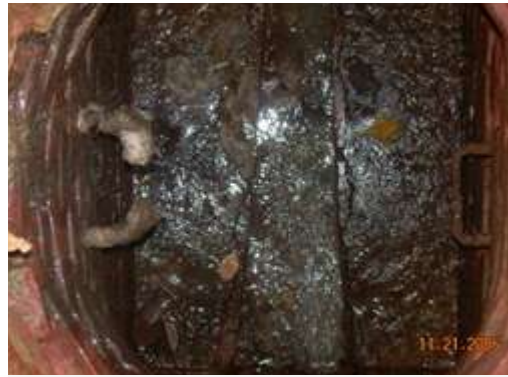
Top View

☒ **Debris** (not Condition related)

☒ **Corroded**

Corroded steps. Bench debris.

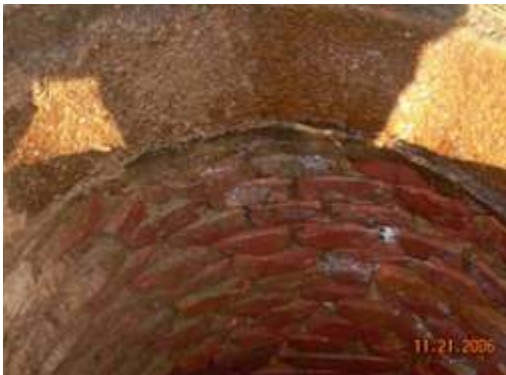
Defect

☒ **Leaks**

Condition: ☐ Sound ☐ Cracked ☐ Root Intrusion ☐ Loose Brick ☒ **Deteriorated**

Infiltration: ☐ None ☒ **Joint** ☐ Cracks ☒ **Mortar** ☐ Roots ☐ Wall

Frame leaks. Adjustment deterioration and infiltration.

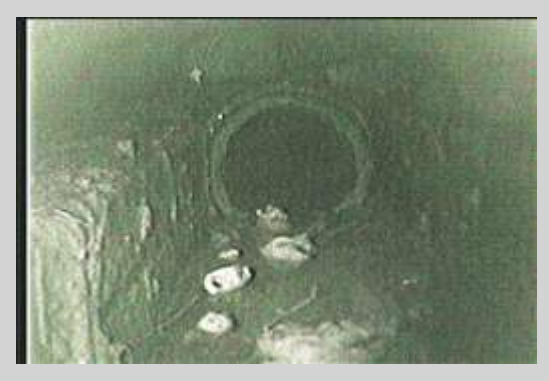
### 6 in. Circular Gravity Sewer Pipe Out @ 12 O'Clock

Deposits: ☐ None ☒ **Mud** ☐ Sludge ☒ **Debris** ☐ Grease

Silt Depth: **0** (in.) Deposits Extent: **Light**

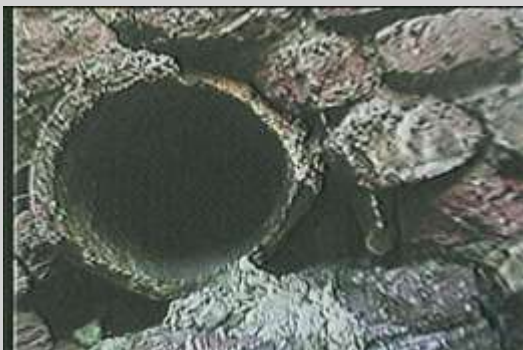
### 6 in. Circular Gravity Sewer

Comments **The I9 pipe comes in approx. 7ft above the Channel.**

Infiltration: **Evidence**

Pipe Seal Cond: **Broken**
